Mr. Hyung-Mo Choi
Manager of Mechanical Department
Tong Yang Cement Corporation
and Eungu Jang, PhD
Manager of Machinery Diagnostics
and Technical Training
Bently Nevada Korea

## Early fault detection avoids downtime

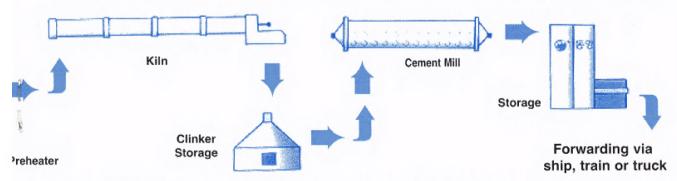
Bearing side of 6th kiln speed reducer.

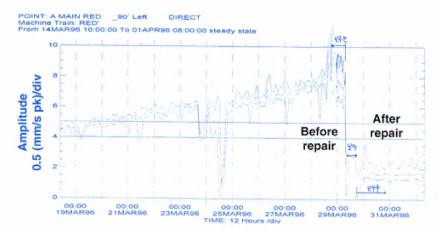
Figure 2
Trendmaster 2000 unfiltered trend plot, showing overall vibration had increased.

speed reducer. The speed reducer is a gearbox which reduces the rotational speed of the motor that drives the kiln. The speed reducer has rolling element bearings and is driven by a 960 hp motor. It is monitored by four accelerometers, two on the inboard side of the motor and two on the pinion side of the reducer. A Trendmaster 2000 for Windows unfiltered trend plot showed that overall vibration had increased (Figure 2). Engineers next viewed two filtered trend plots, to further isolate the problem. The first plot was of data filtered to the rotor vibration region (Figure 3). It showed no vibration increase. The second plot was a Prime Spike trend plot. Prime Spike plots, created by Trendmaster 2000 for Windows, emphasize flaws in the inner or outer races of rolling element bearings. The Prime Spike trend plot (Figure 4) showed an increase in vibration similar to the unfiltered trend plot. TYC's engineers suspected that bearing failure was imminent.

Plant engineers closely monitored the machine. A week later (Figure 2, 28MAR96), vibration levels increased again. Engineers used Trendmaster 2000 for Windows to generate a frequency spectrum plot (Figure 5), which verified the Prime Spike data. It showed a large, bearing-related 214 Hz frequency component, which was within the Prime Spike frequency region. The machine was shut down and inspected. Significant bearing wear was found (Figure 6).

The bearing was replaced, and the reducer was returned to service. Its vibration returned to normal (Figures 2 and 4, 29MAR96).

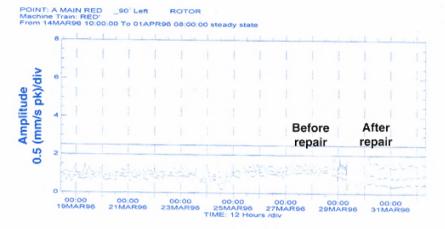
Figure 3
Trend plot of data filtered to rotor speed, showing no vibration increase.

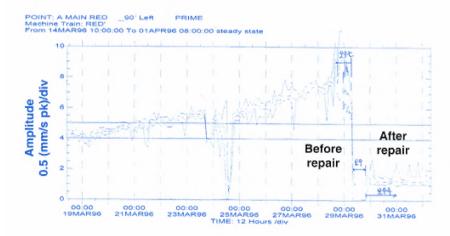
Figure 4
Prime Spike trend plot, showing an increase in vibration.

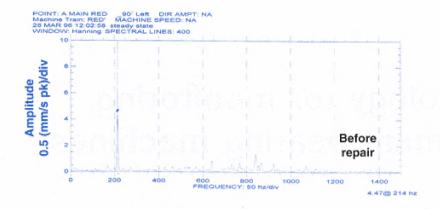
Figure 5
Spectrum plot which verified the Prime Spike data in Figure 4.
